AN EXTENSIVE INSPECTION OF THE FORKLIFT FB25-77 IN THE MANUFACTURING SECTOR BASED ON INDONESIAN MINISTRY OF LABOUR REGULATION

The principal objective of this culminating research initiative is to conduct a thorough examination and assessment of a Nichiyu Forklift Model FB25-77, identified by Serial Number 257C02643. The research is focused on discerning the overall performance of the forklift, which has been actively in operation for an estimated duration of four years. This mandatory scrutiny is in accordance with the regulations established by the Minister of Labor of the Republic of Indonesia through Regulation Number 08 of 2020, explicitly detailed in Chapter 7, Article 176, Paragraph 1. The stipulations of this regulation mandate the execution of inspection tests for lifting and transport equipment, not exceeding two years after the initial inspection and subsequently on an annual basis.

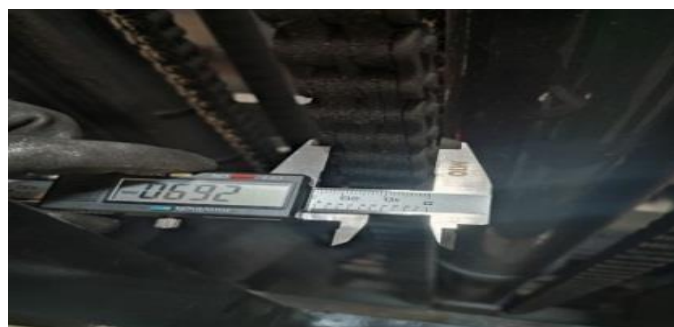
Figure 1 illustrates the accurate measurement of the chain thickness, while Table 3 provides a detailed explanation of the results obtained from measuring the thickness of the forklift chain. Drawing from the information in Table 3, the tabulated data outlines the dimensional measurements for the years 2022 and 2023. It is noteworthy that there is no discernible alteration in the results over the course of one year.

Figure 1. Forklift chain-thickness measurement.

In accordance with the stipulations outlined in Permenaker No. 08 of 2020, Article 36, paragraph 1 (c2), it is prescribed that the wear of the initial link must not exceed 10% (ten percent) of the original diameter. This assessment involves measuring the chain thickness from pin to pin, resulting in a measurement of 23 mm, and considering pin diameters of 7 mm, in alignment with the authentic field conditions.

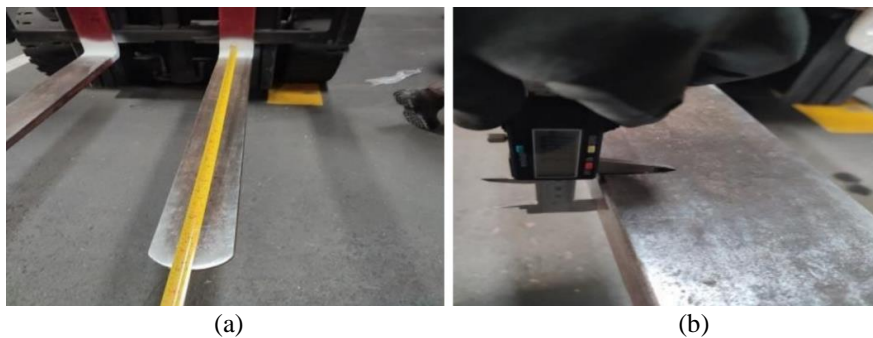
Figure 2 demonstrates precise measurements of the forklift fork length and thickness, complemented by an elaborate

elucidation of the obtained results for the fork's length and thickness in Table 4.

In accordance with Minister of Manpower Regulation No. 08 of 2020, specifically outlined in Chapter 77, paragraphs 1 (b, d, f), compliance mandates that Fork No should not undergo a deflection surpassing 1/33 (one-third) times its length (b), avoid thinning of the fork by more than 10% (ten percent) (d), and ensure that there is no height difference exceeding 3% (three percent). Additionally, for forklifts utilizing a double fork (f), the specified length criteria must be adhered to.

Figure 2. Forklift's fork section measurement; (a) Fork length, (b) Fork thickness.

Through the computation, where Maximum Deflection is calculated as 1/33 times the fork's length (107mm), resulting in 3.24mm, and the Actual Deflection is determined as the difference between the initial height and the final height (775mm – 773mm = 2mm), it is evident that the actual deflection is below the maximum permissible deflection. This computation affirms the alignment of the fork with the specified conditions.

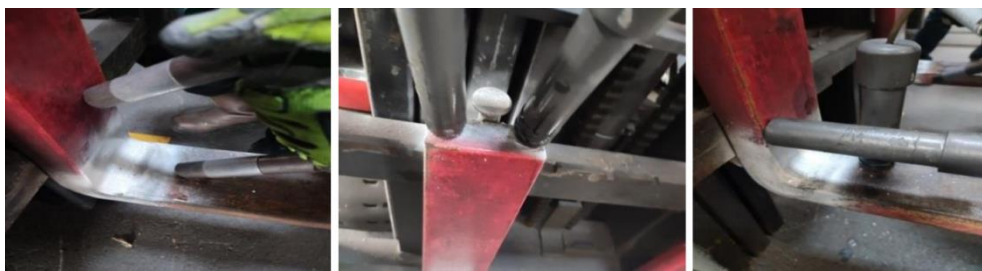
Table 5 and Figure 3 delineate the utilization of the Non-Destructive Testing (NDT) method for scrutinizing the fork connection/welding region. The outcomes from the NDT process reveal the absence of any defects or cracks, thereby confirming the favorable condition of the fork.

Figure 3. NDT on a fork's welding connection (a) HAZ area, (b) Pin's location, and (c) Specified HAZ point
